DECEMBER 2018

HEADLAMP LENS DETERIORATION

Abstract

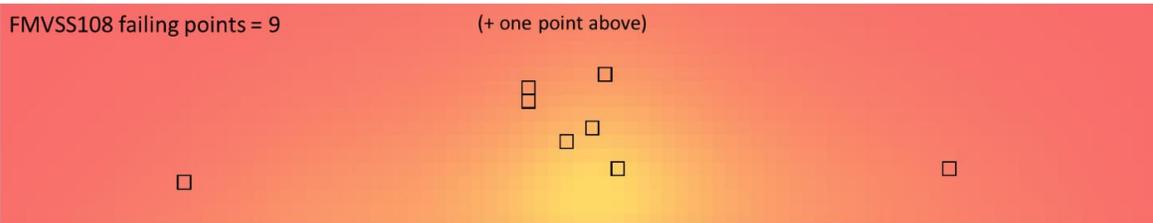
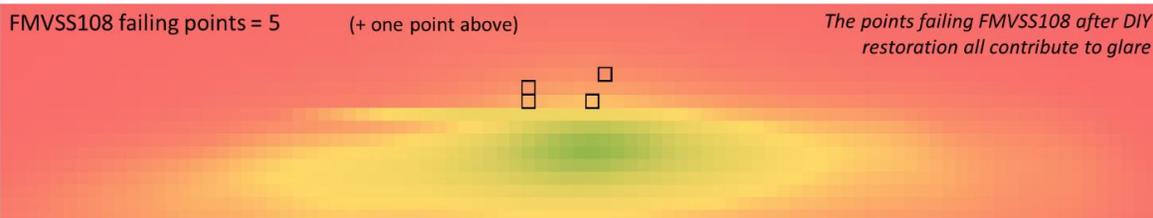
Figure 7: FMVSS-108 Low Beam failure points for Altima Used #1

The example below indicates the failure points for testing the Nissan Altima used (1) headlamp on low beam. Appendix B is exhaustive in comparing OEM to aftermarket, certified to non-certified part and before and after restoration of used parts.

Altima Used #1 Low Beam in deteriorated condition

Altima Used #1 Low Beam restored with DIY kit

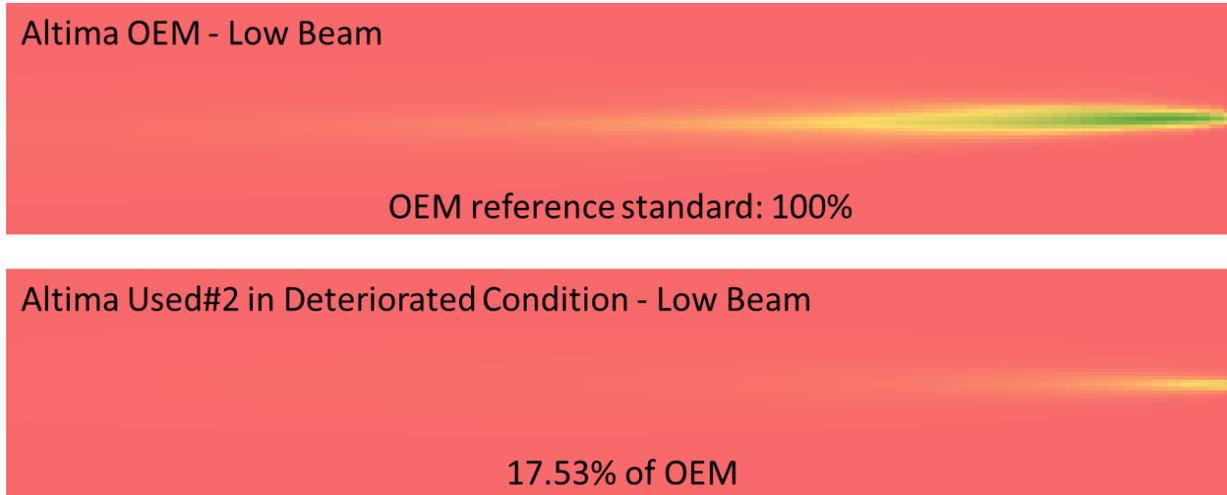
Figure 17: Comparison of Nissan Altima OEM light output vs. used

The following example compares the forward lighting provided by a new OEM headlamp and a deteriorated lamp in low beam operation. The top image is the OEM replacement assembly. The lower birds-eye plot is a used Nissan Altima headlamp. When averaged, the forward lighting values from all four used headlamps (two Chevy Malibu and two Nissan Altima) resulted in light output of 22.43 percent in comparison to the OEM light output.

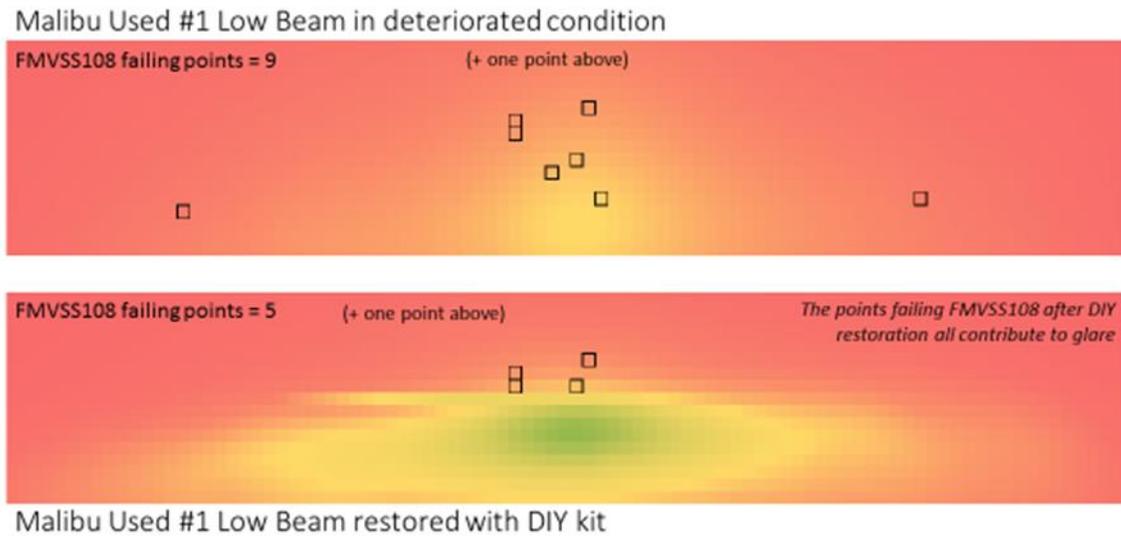
Figure 21: Comparison of deteriorated and restored light intensity failure points

In the example shown in figure 21, several test points that failed to meet minimum light output levels were corrected by the headlamp restoration process. Failure points shown for the restored headlamp are above the horizontal level and are associated areas of the headlamp beam that produce glare. After restoration, the headlamp produced too much light in the indicated test points. Refer to Appendix B for failure locations on all tested lamps (Chevy Malibu and Nissan Altima, low beam and high beam).

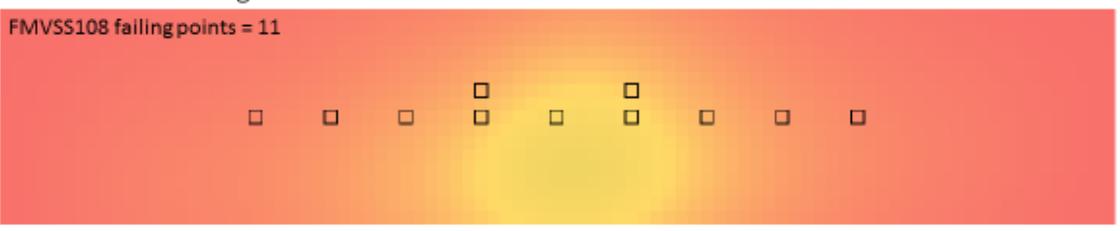
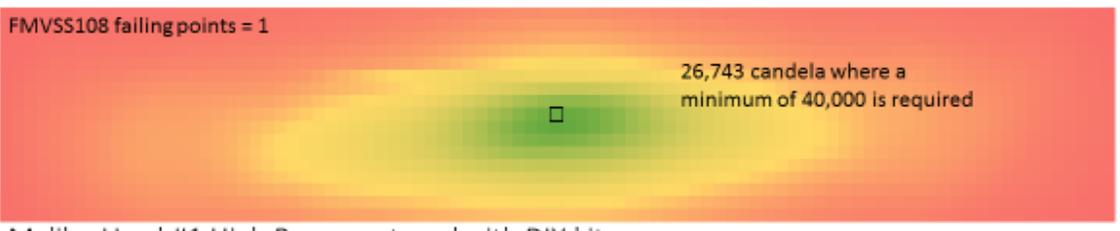
Malibu Used #1 High Beam in deteriorated condition

FMVSS108 failing points = 11

FMVSS108 failing points = 1

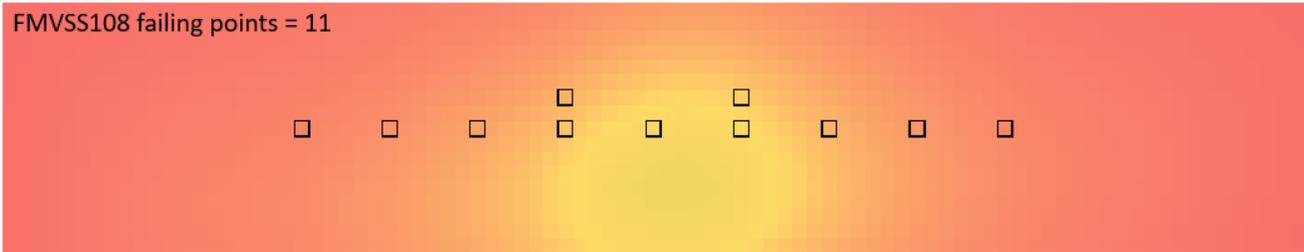
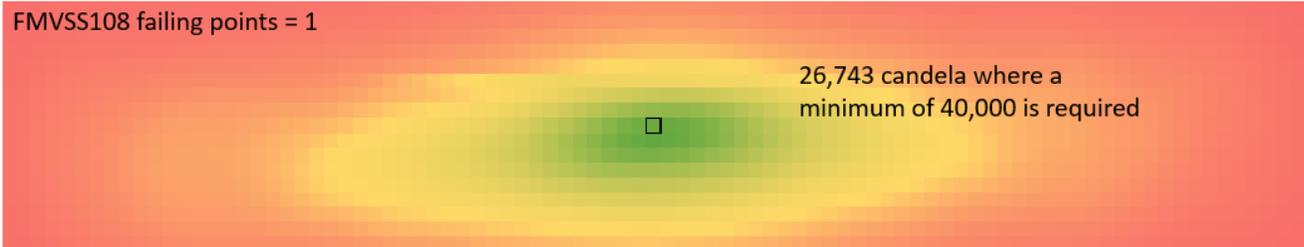
Altima Used #1 High Beam in deteriorated condition

FMVSS108 failing points = 11

FMVSS108 failing points = 1

26,743 candela where a minimum of 40,000 is required
