DECEMBER 2018

HEADLAMP LENS DETERIORATION

Abstract

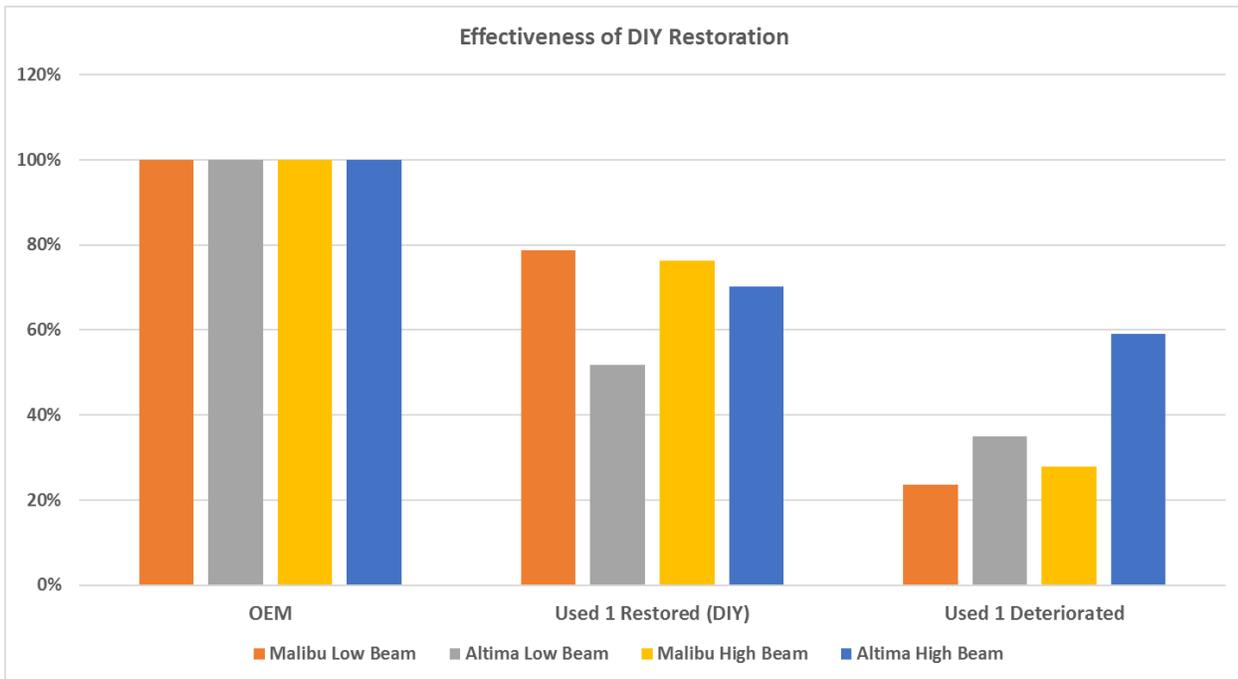
Figure 8: Effectiveness of DIY Headlamp Lens Restoration

The following two charts show the deteriorated and post-restoration light output of the used headlamps.

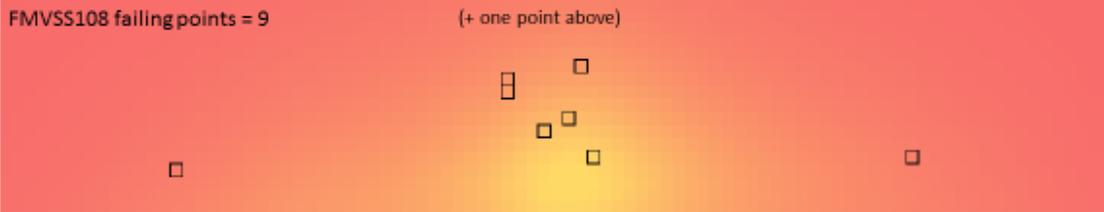
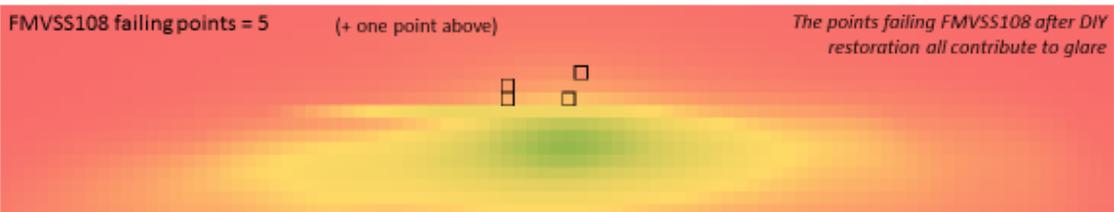
Malibu Used #1 Low Beam in deteriorated condition

Malibu Used #1 Low Beam restored with DIY kit

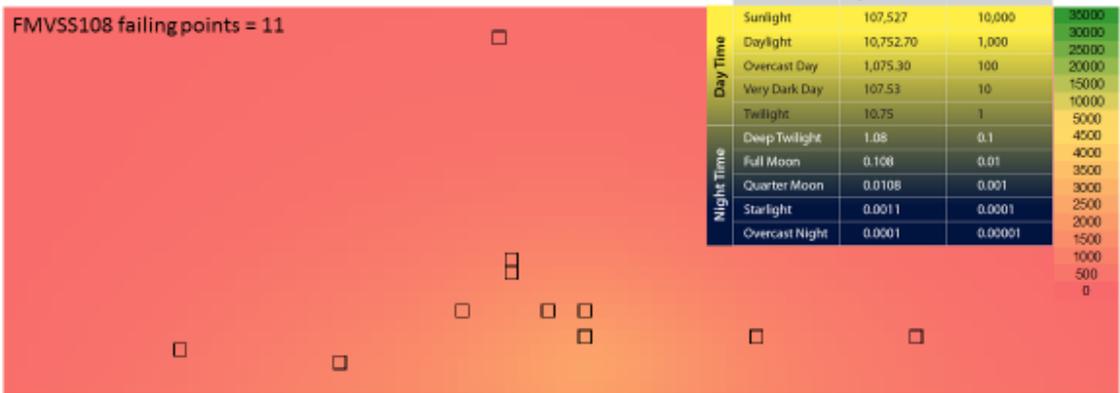
Malibu Used #2 Low Beam in deteriorated condition

The full ISO scan is 68,229 data points.
 This image is zoomed to show 3,185 points of the full scan (4.6%).
 The highest value on this scan is 2376.7 lux.

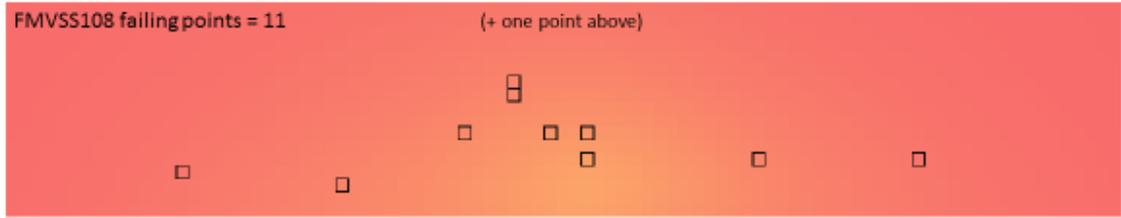
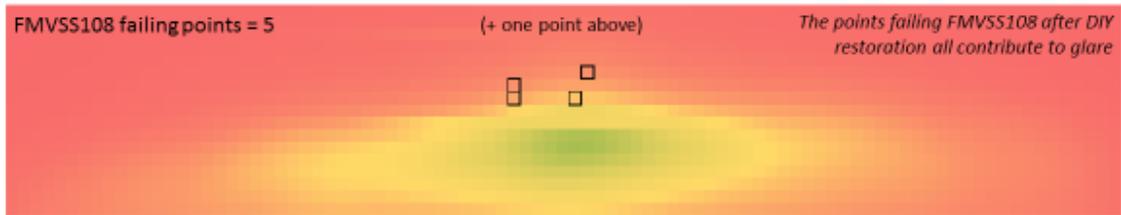
Malibu Used #2 Low Beam in deteriorated condition

Malibu Used #2 Low Beam after PRO restoration

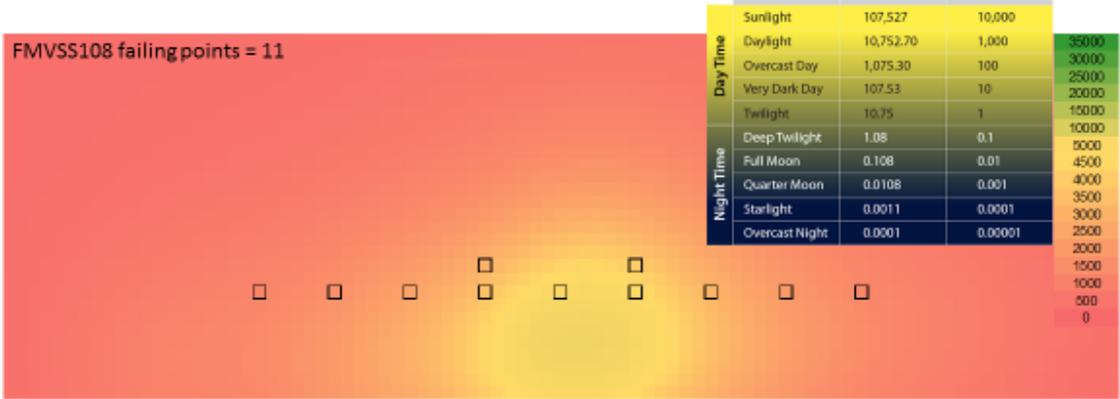
Malibu Used #1 ISO High Beam

FMVSS108 failing points = 11

The full ISO scan is 68,229 data points.
 This image is zoomed to show 2,581 points of the full scan (3.8%).
 The highest value on this scan is 43,289.2 lux.

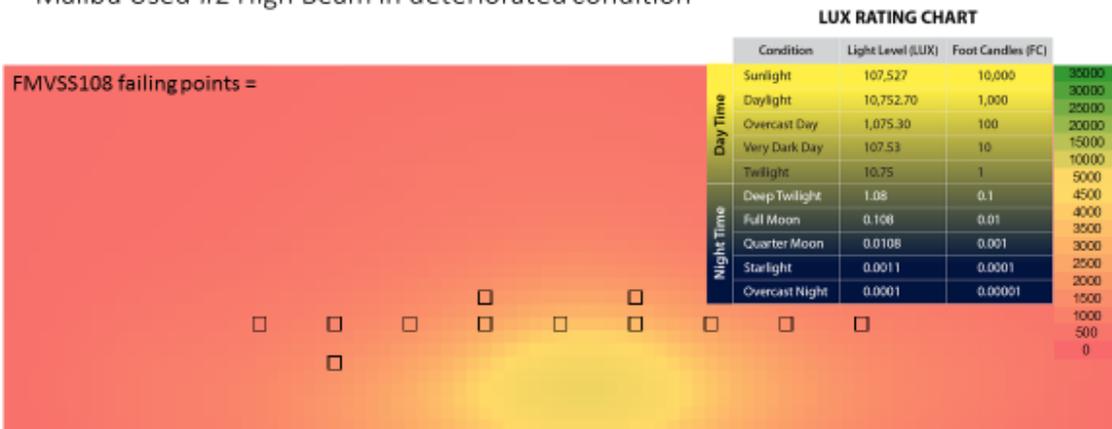
Malibu Used #2 High Beam in deteriorated condition

The full ISO scan is 68,229 data points.
 This image is zoomed to show 2,581 points of the full scan (3.8%).
 The highest value on this scan is 6,951.0 lux.

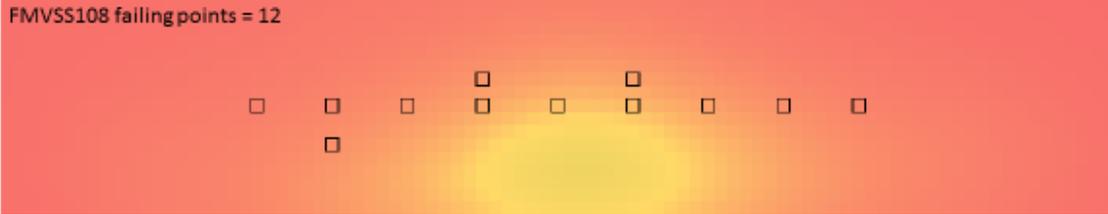
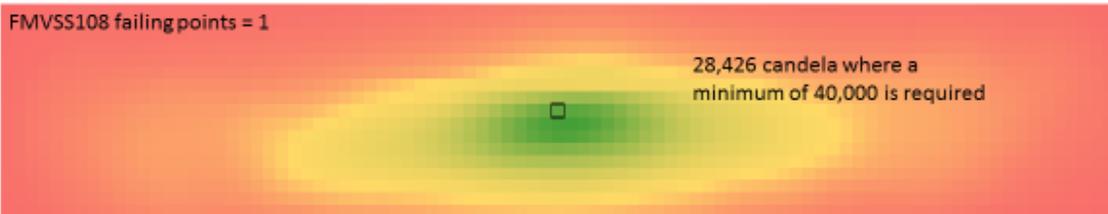
Malibu Used #2 High Beam in deteriorated condition

Malibu Used #2 High Beam after PRO restoration

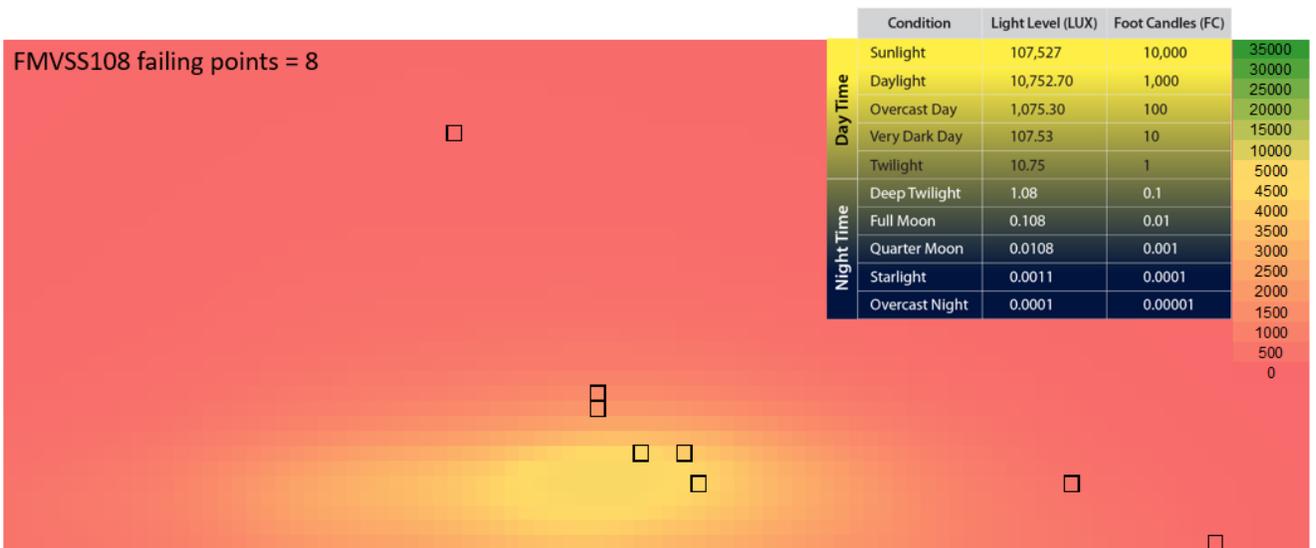
Altimax Used #1 Low Beam in deteriorated condition

The full ISO scan is 68,229 data points.
 This image is zoomed to show 3,185 points of the full scan (4.7%).
 The highest value on this scan is 5441.0 candela.

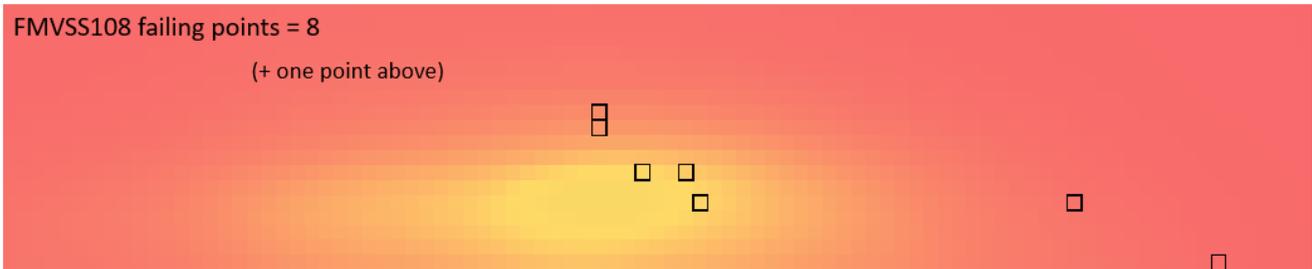
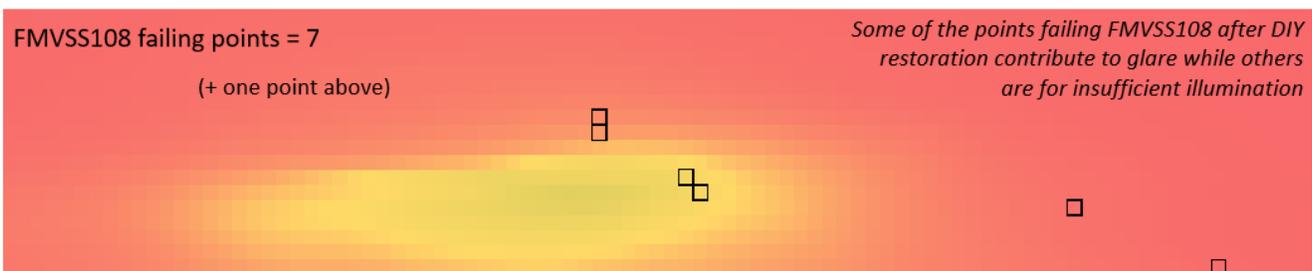
Altima Used #1 Low Beam in deteriorated condition

Altima Used #1 Low Beam restored with DIY kit

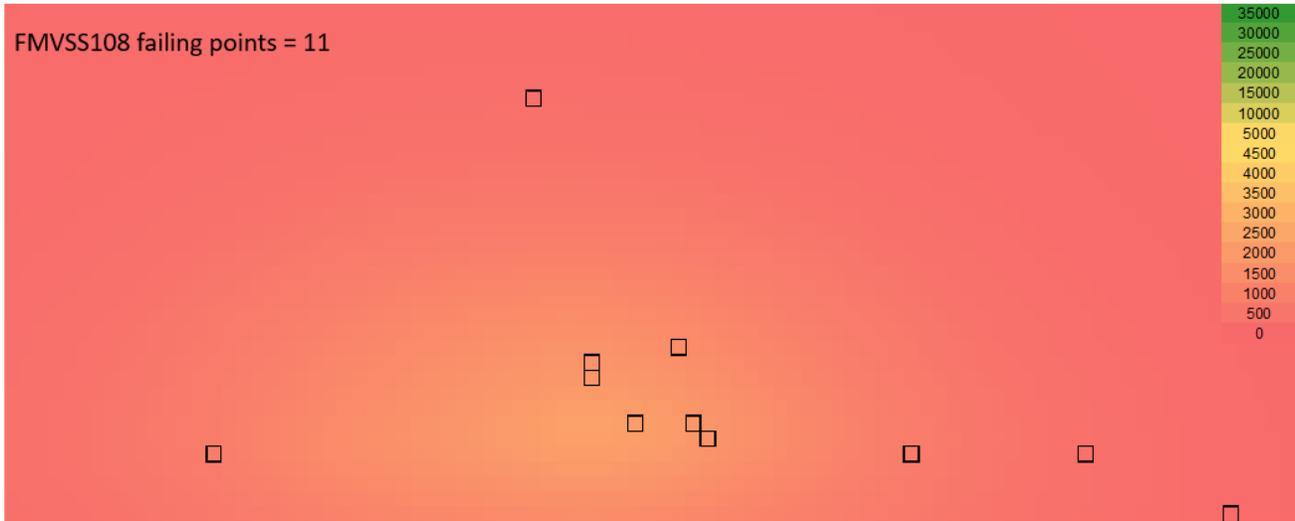
Altima Used #2 Low Beam in deteriorated condition

The full ISO scan is 68,229 data points.
This image is zoomed to show 3,115 points of the full scan (4.6%).
The highest value on this scan is 2,274.7 candela.

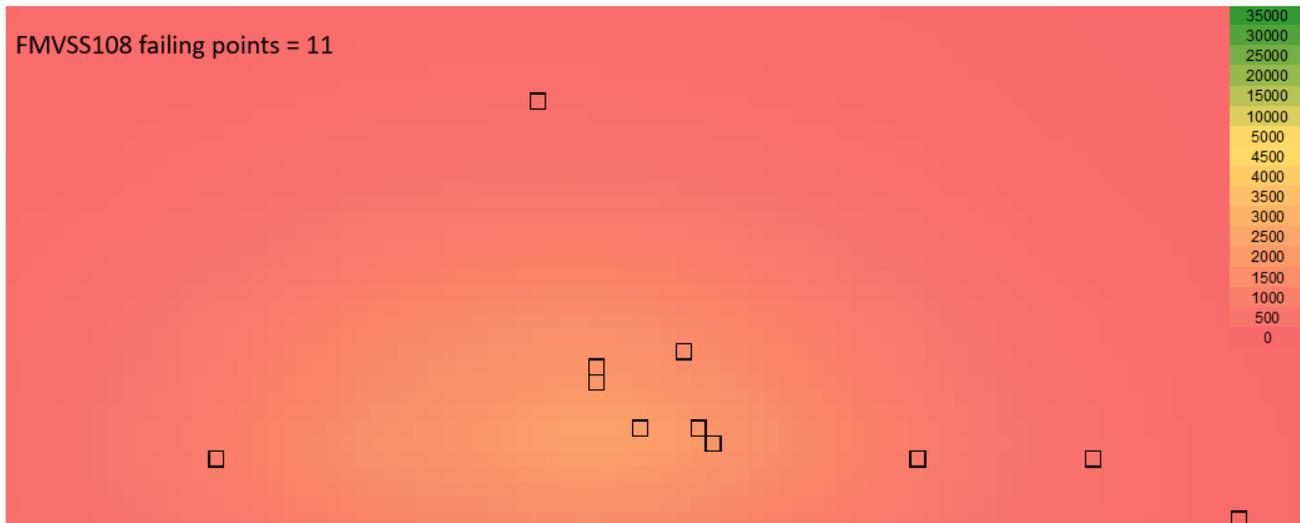
Altima Used #2 Low Beam in deteriorated condition

The full ISO scan is 68,229 data points.
This image is zoomed to show 3,115 points of the full scan (4.6%).
The highest value on this scan is 2,274.7 candela.

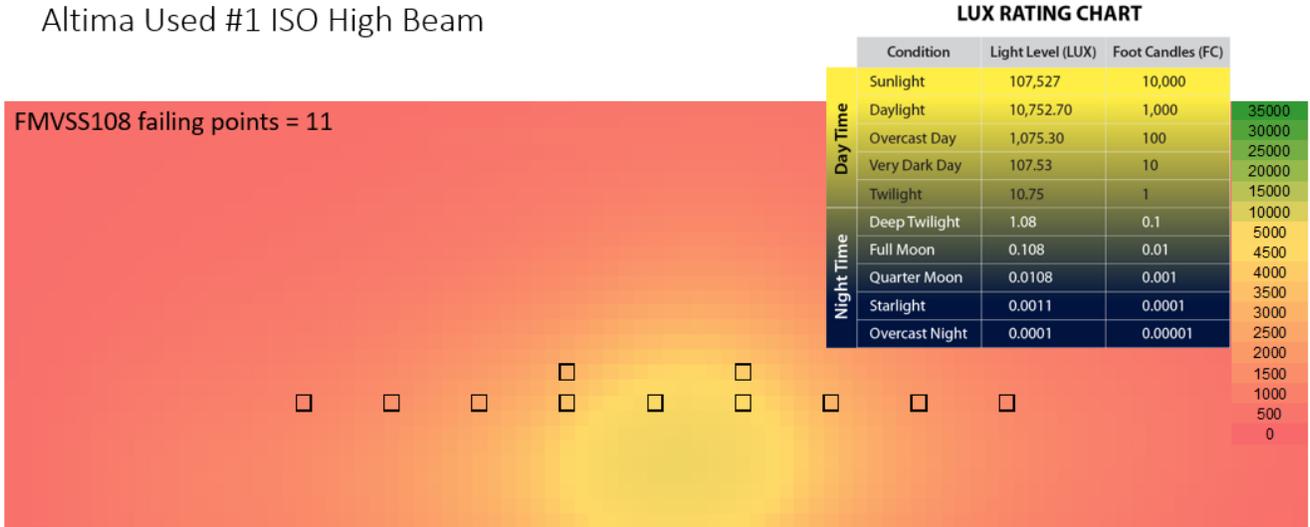
Altima Used #1 ISO High Beam

The full ISO scan is 68,229 data points.
 This image is zoomed to show 2,581 points of the full scan (3.8%).
 The highest value on this scan is 43,289.2 lux.

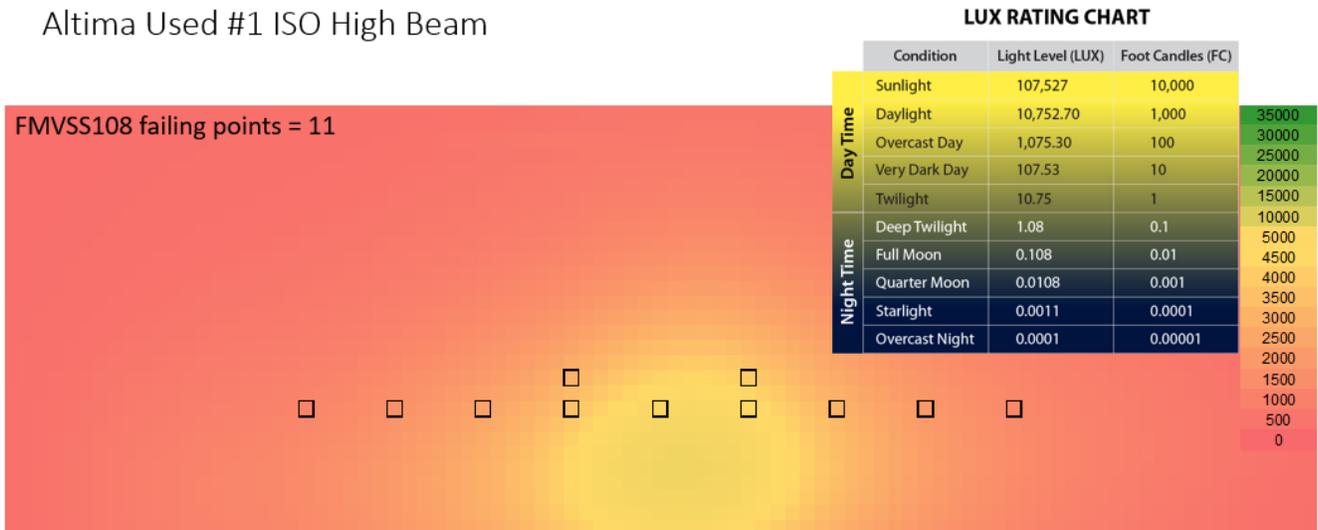
Altima Used #1 ISO High Beam

The full ISO scan is 68,229 data points.
 This image is zoomed to show 2,581 points of the full scan (3.8%).
 The highest value on this scan is 43,289.2 lux.

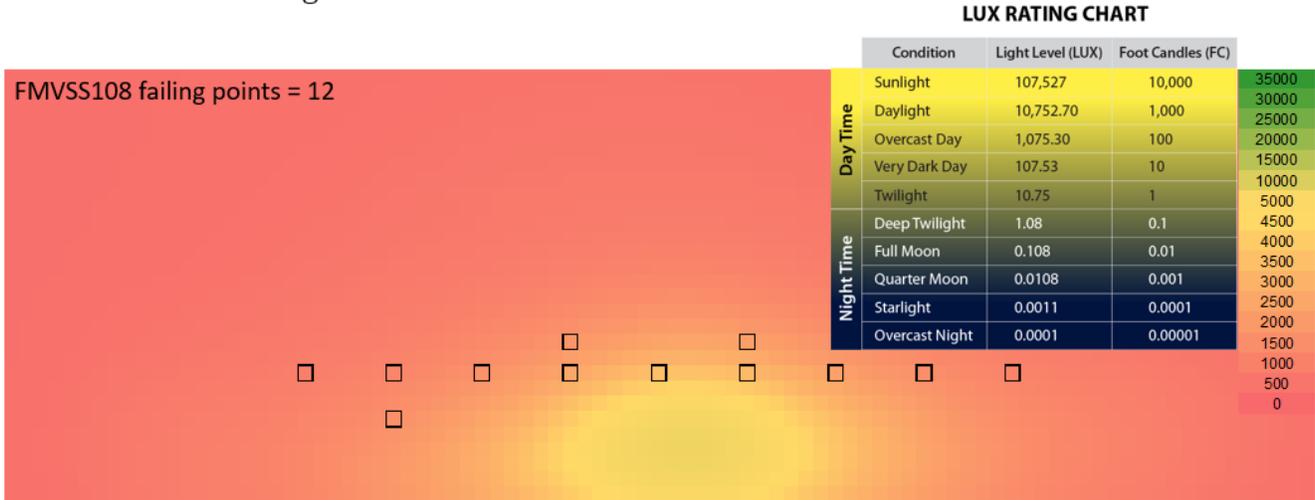
Altima Used #2 High Beam in deteriorated condition

The full ISO scan is 68,229 data points.
 This image is zoomed to show 2,581 points of the full scan (3.8%).
 The highest value on this scan is 6,951.0 lux.
